EVALUATION OF PREMATURE FAILURE ACCOUR IN SRP PUMP TO IMPROVE RUN LIFE PUMP IN HASA FIELD

ABSTRACT

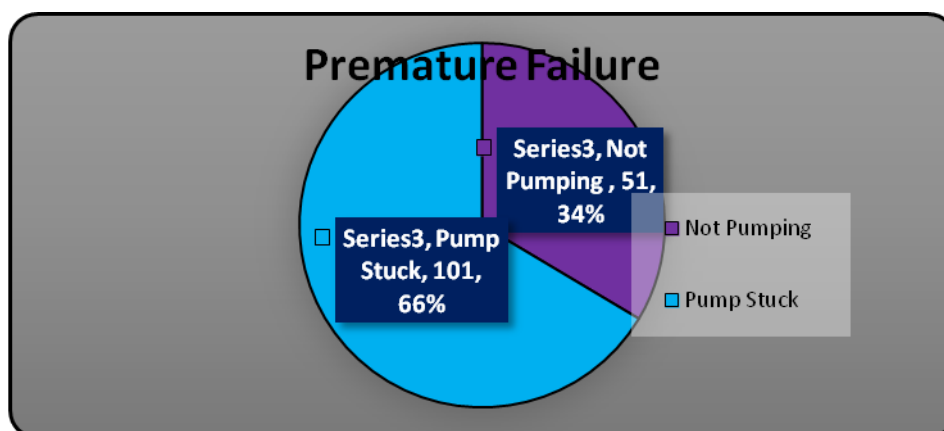
Figure 1. Percentage of damage to premature failure that occurs in the HASA field

Based on picture 1, pump stuck was obtained, there were 101 cases or the percentage was 66% and pumping notes, there were 51 cases or the percentage was 34%. Pump stuck failure occurs because of the sand that is produced in the tubing so it will be very disturbing when the pump works, which makes the clearance or gap between the plunger and barrel pump become scratched. As a result of the sand particles produced on the pump, the pump becomes stuck or stuck in the pump because the gap between the plunger and the barrel pump is filled with sand particles, so the power of the prime mover is no longer able to pull the pump during a stroke or down stroke, so the pump becomes die or stop. The data on sand production in HASA Field shows an increase in the average sand produced into the wellbore before the occurrence of premature failure. Following is the sand rate data in the HASA Field on pump stuck failure.

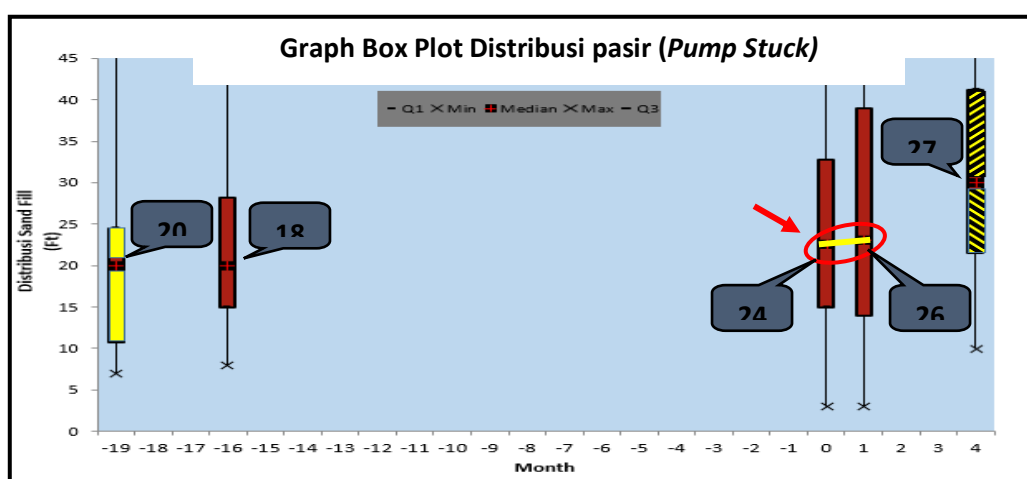
Figure 2 Graph of sand production in HASA Field

Figure 2 shows the average increase in sand produced in the wellbore, where the average sand increases before damage of 24 ft and after the damage occurs the average is 26 ft. The presence of sand that enters the pump causes an increase in temperature inside the pump, because the sand is sandwiched between the gap of the tubing and plunger, so that during up stroke and down stroke there is excessive friction which makes the heat increase in the barrel tubing. However, the

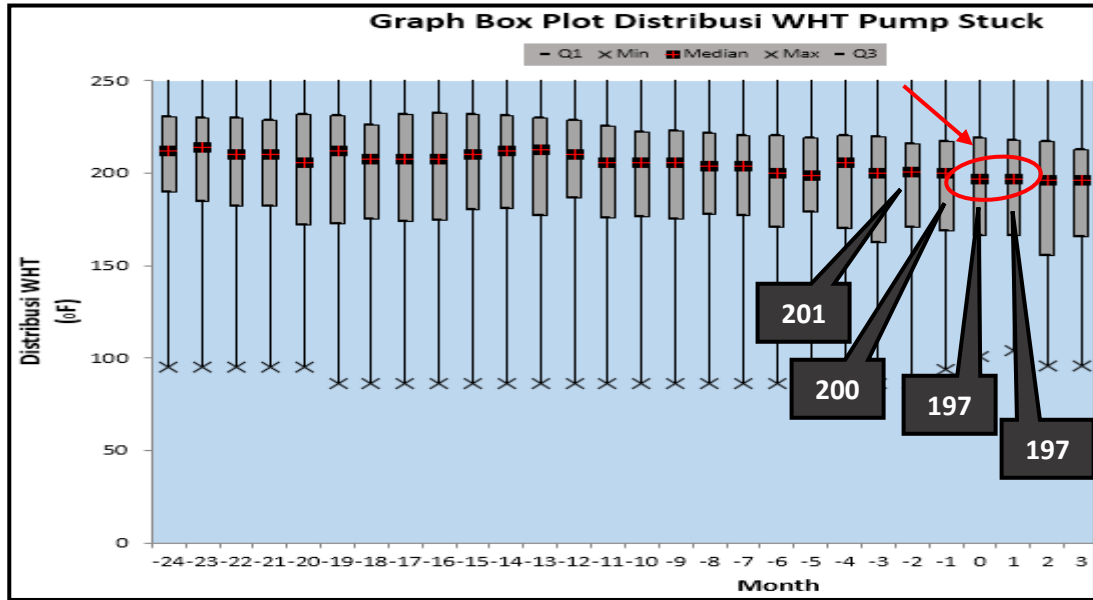
Figure 3. Graphic Well Temperature Head at HASA Field

temperature at HASA Field did not experience a significant temperature increase, the temperature before the damage occurred at 197 of and after the replacement of the new pump and the pump experienced a return of the last temperature of 197 of. This is because when the pump is damaged, the pump is immediately stuck or stopped due to friction between the plunger and tubing pump. So that the device that measures the temperature at the well head temperature measures the last temperature of the fluid.

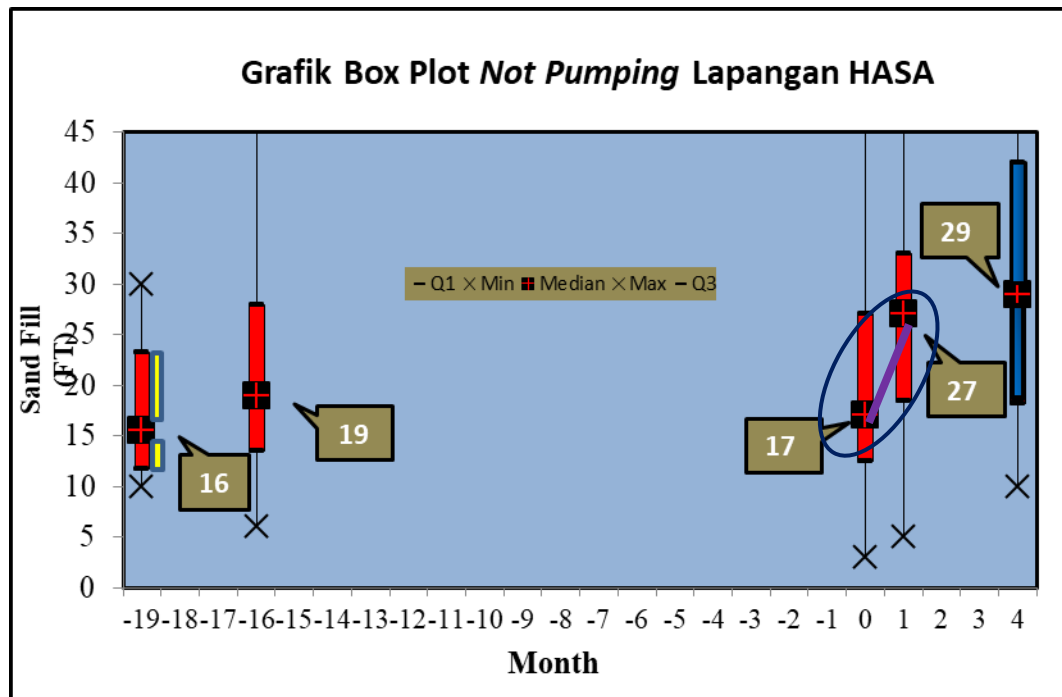
Figure 4. Graph of sand distribution at the pump in the HASA field

Figure 4 shows the significant increase in sand production in the wellbore. Can be seen when the pump is damaged, the sand thickness in the wellbore is 17 ft on average, while at the time of the new pump changes, and the pump is damaged again, the sand produced in the wellbore has an average increase of 27 ft. The presence of sand particles produced also makes load and temperature cause unstable. When the Not Pumping damage occurs, the area card on the surface will read the load received by the rod to change and become unstable.

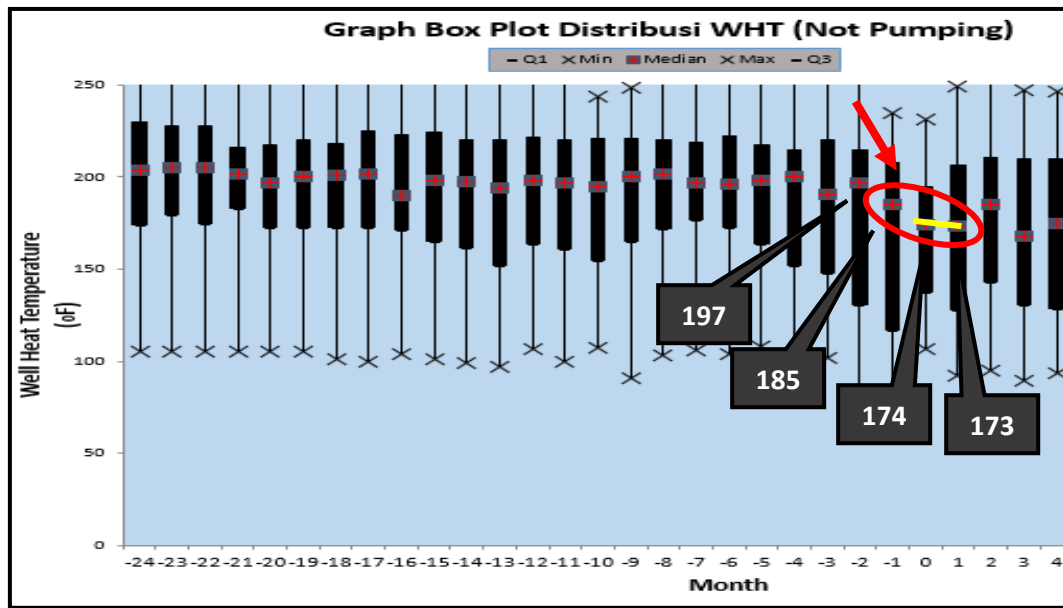
Figure 5. HASA Field Temperature Well Graph

In addition, at 3 months before experiencing damage, the well head temperature graph showed a significant decrease from 185 Of to 174 °f, and after experiencing a new pump change, with a duration of less than 30 days, the pump was damaged again and the temperature showed a decrease of 173 °f
